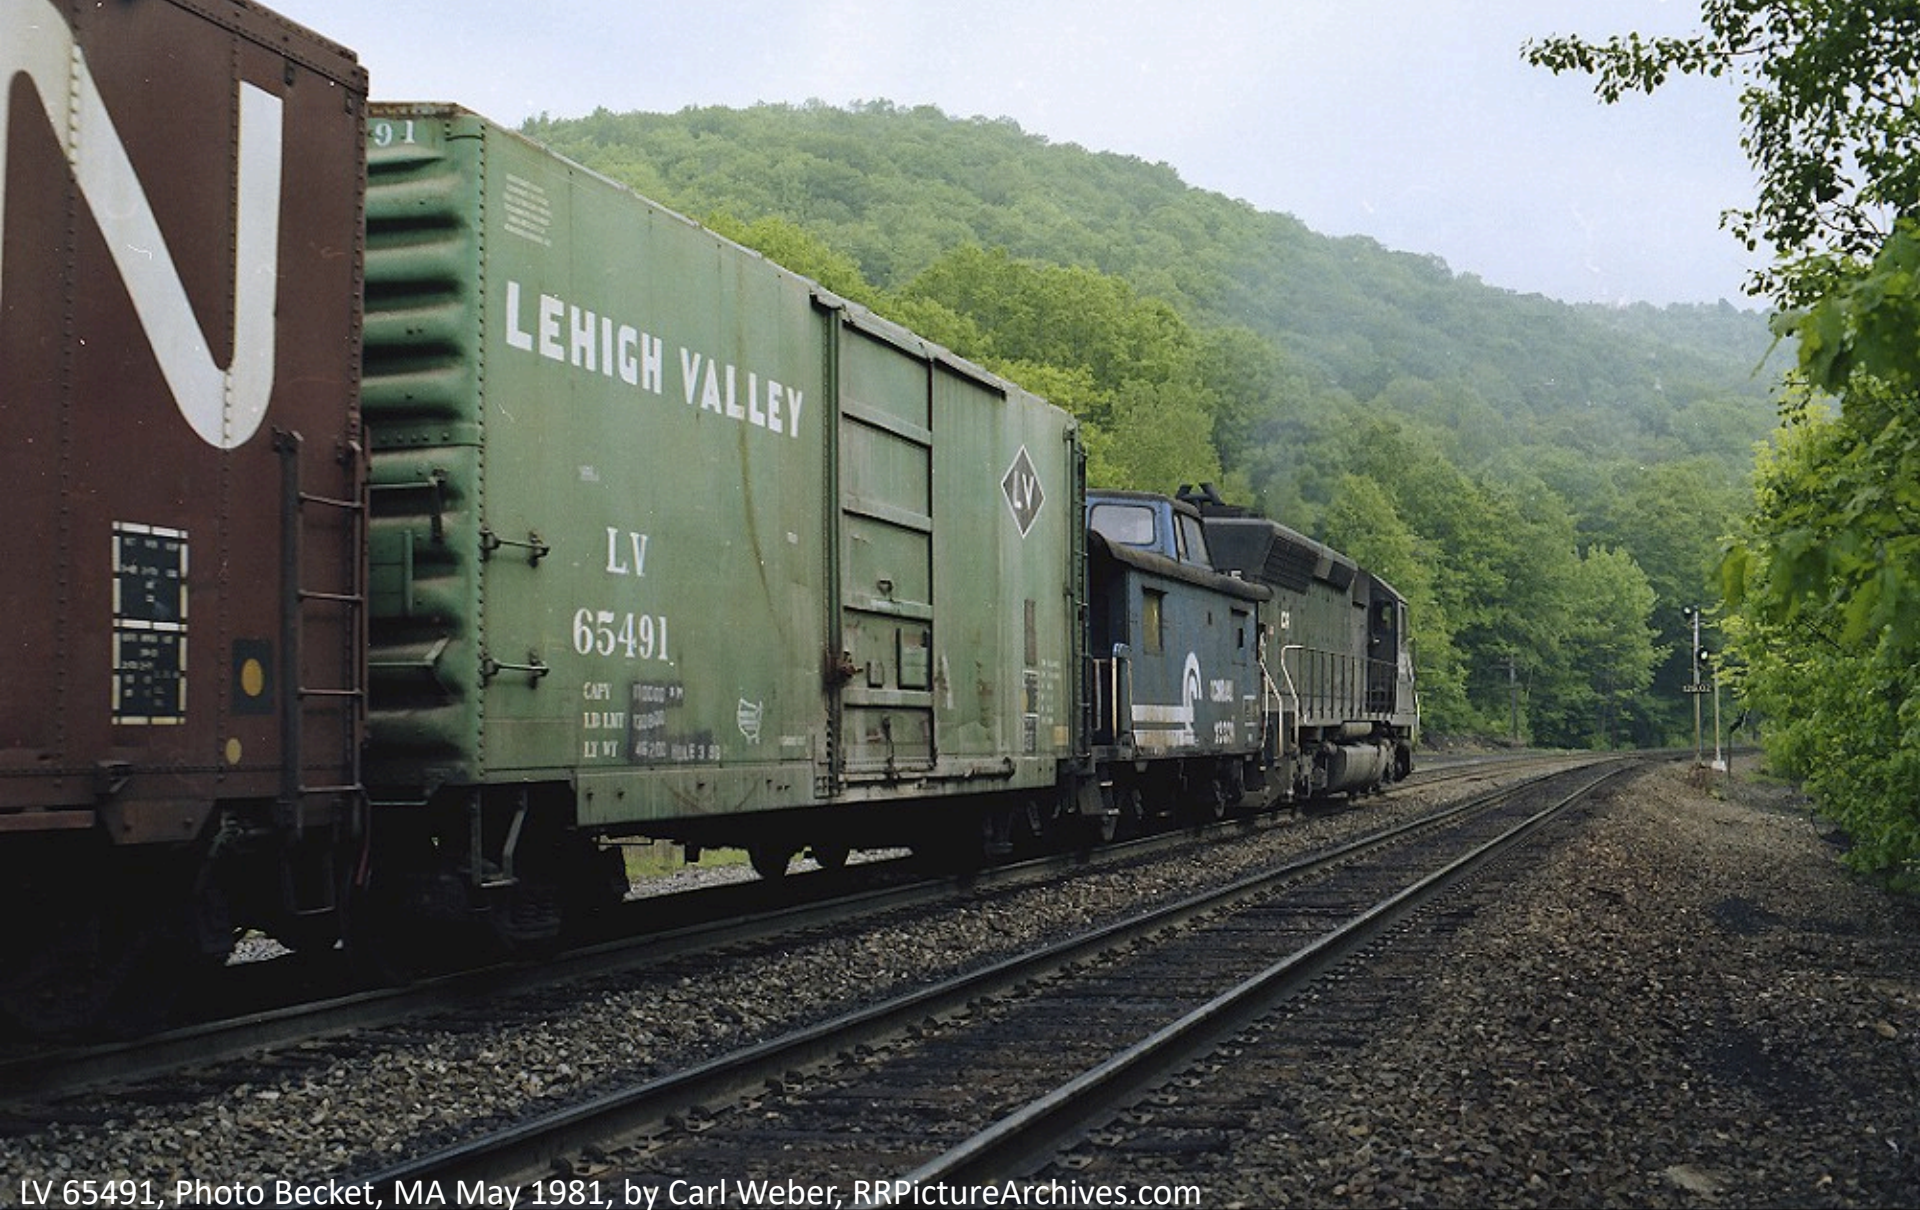
LV 65491, Photo Becket, MA May 1981, by Carl Weber, RRPictureArchives.com
RRPictureArchives.NET Image Copyright Carl Weber

Original
Roofwalk
Supports

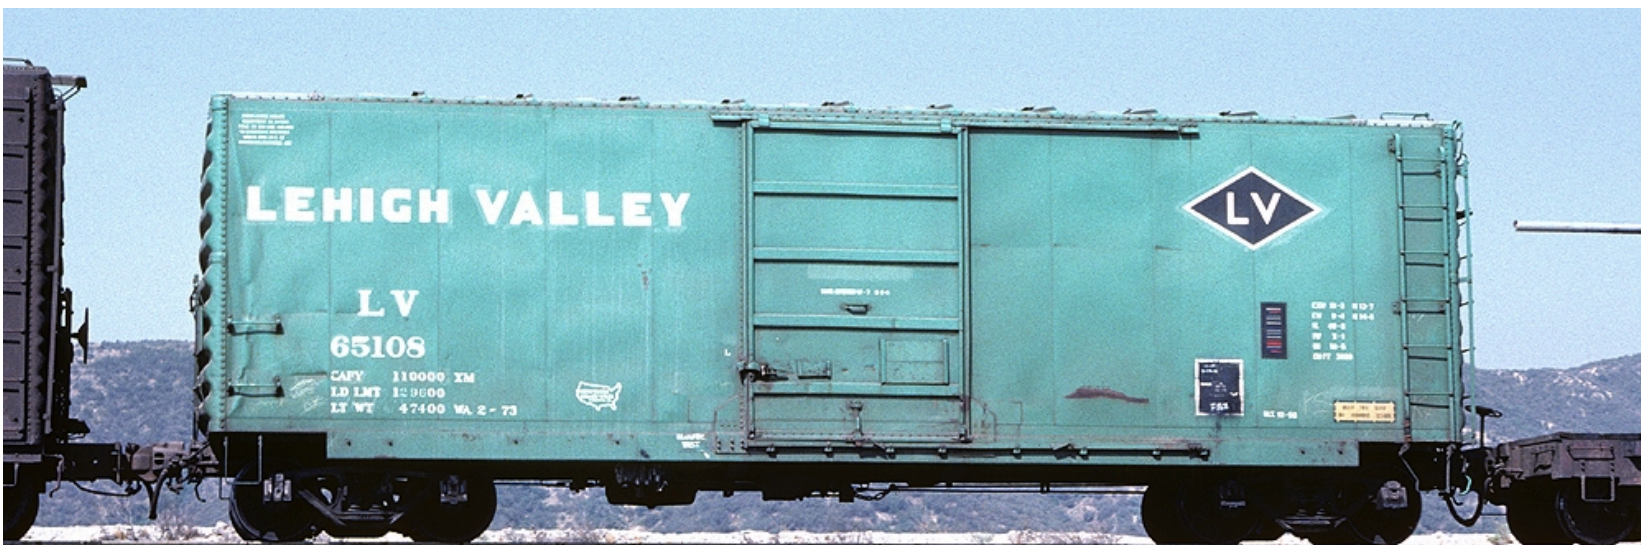
LV 65108, Photo July 1977 in Devore, CA by Steven Vincent, railcarphotos.com

New
Stanray
Roofs, No
Supports

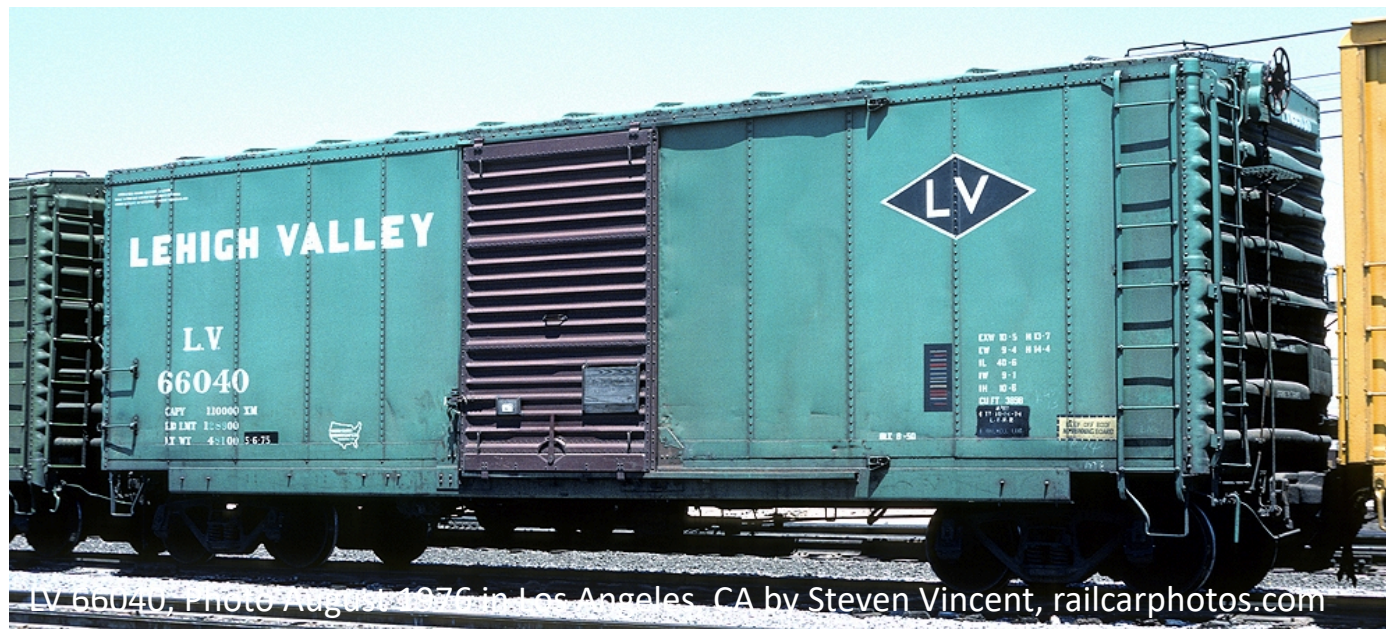
Full original brake gear

Replacement doors, brake wheel

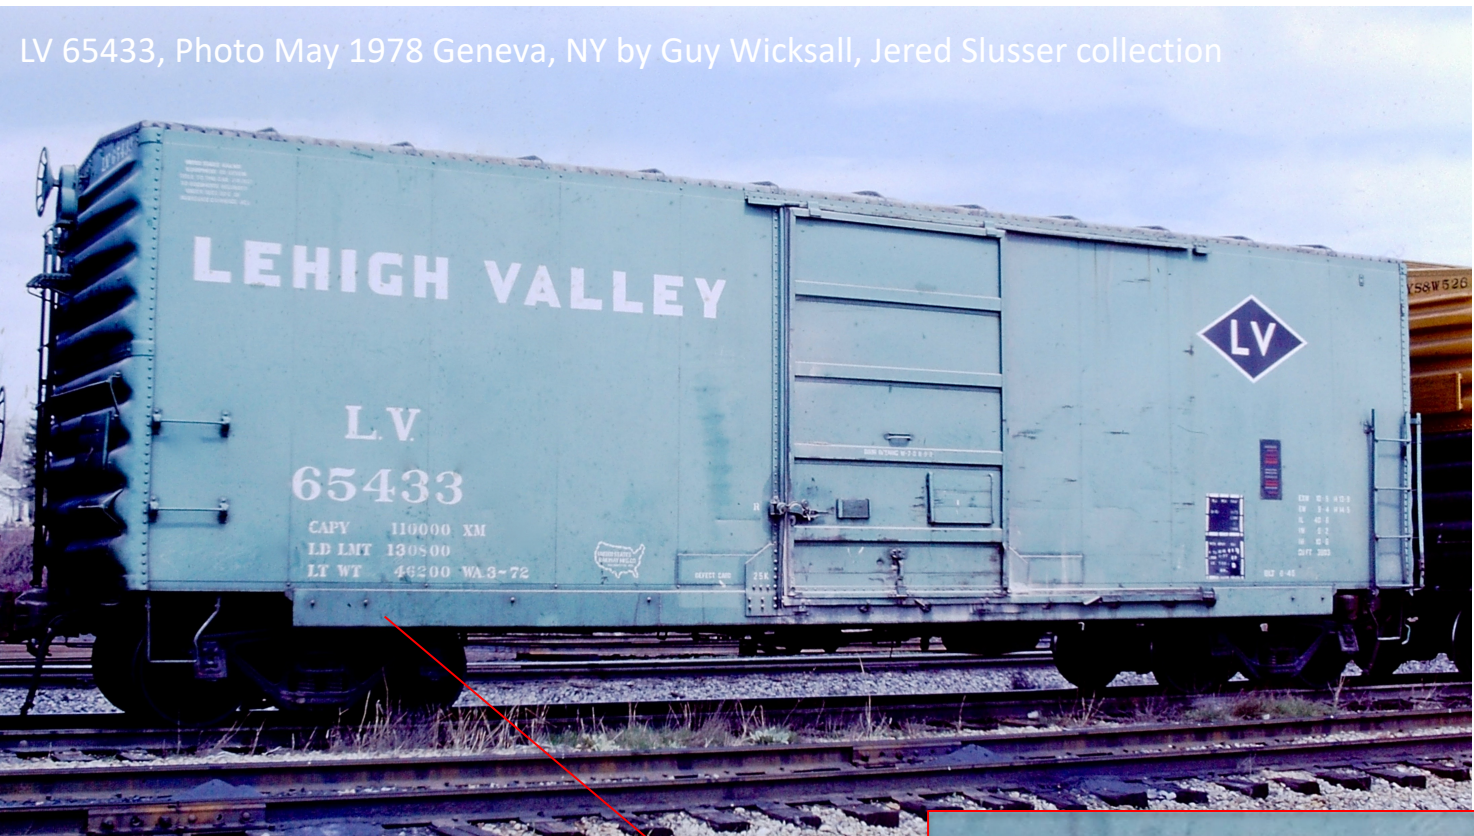
LV 65433, Photo May 1978 Geneva, NY by Guy Wicksall, Jered Slusser collection

Most full re-builds from USRE had the distinctive straight reinforced sill which stopped in line with the bolsters, and all re-builds and re-conditioned cars received the USRE map logo
